## Case History

### Underwater Side Shell Repair

### FPSO Brazil

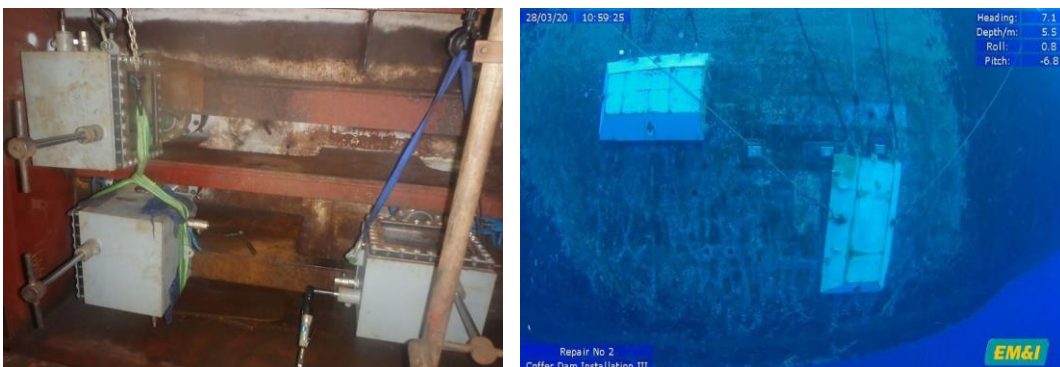
Internal ODIN winch boxes and external ODIN cofferdams

This experience was used to design and implement a system to install a much larger 'cofferdam' sealing arrangement overlapping the steel plates to be replaced.

Key features of the EM&I solution include the unique use of ODIN access ports and winch boxes, the use of practical cofferdams and the integration of our specialized ROVs.
