Radiation Backscatter-Based Non-destructive Technology Detects Corrosion under Insulation on Offshore Oil and Gas Platforms

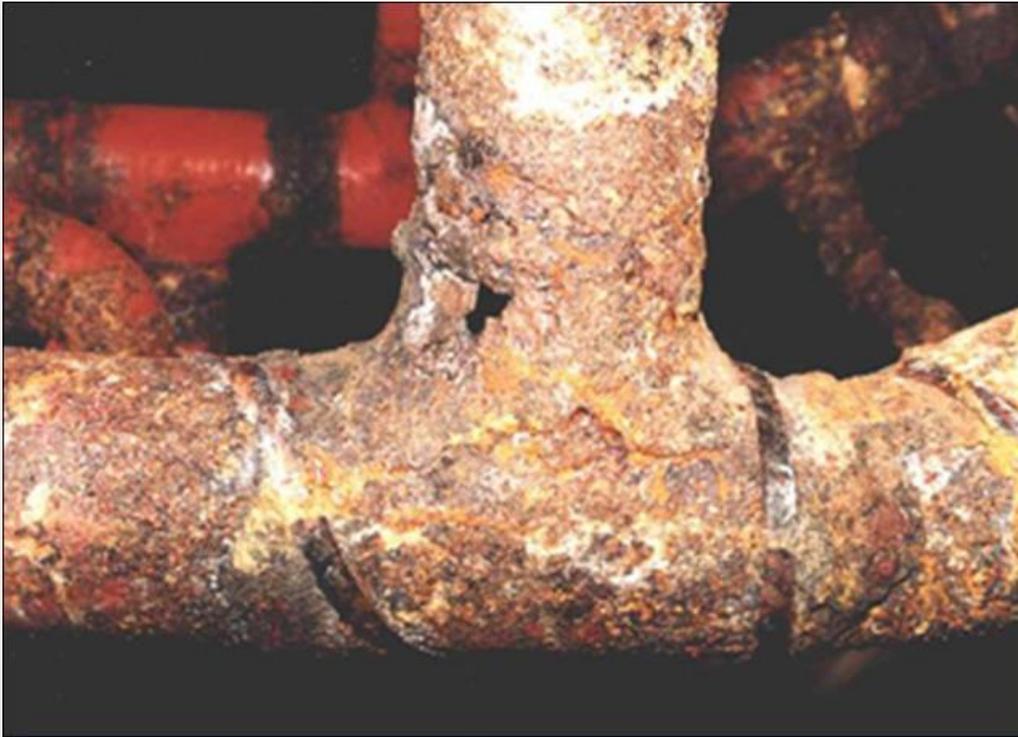
Typical pipe damage caused by CUI. Photo courtesy of EM&I Stantec.

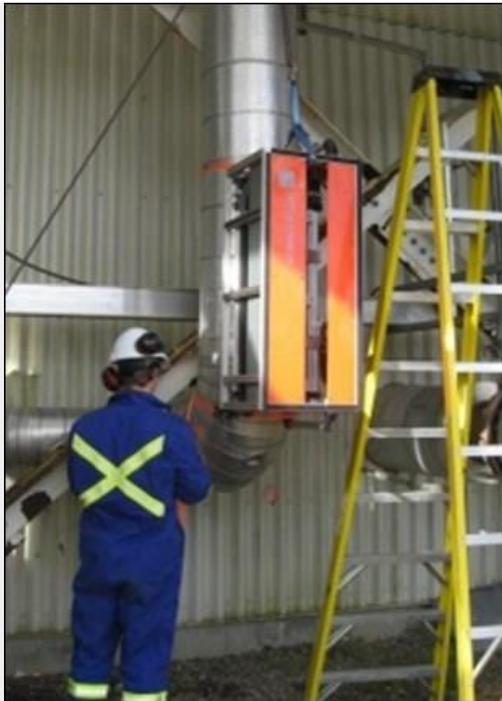
A BCT scanner, hoisted into place with an overhead line, is strapped to a 12-in (305-mm) insulated process gas line. Photo courtesy of EM&I Stantec and Inversa.

Unlike a CT scan, where the object to be imaged is placed inside the scanner and transmitted radiation is measured, a BCT scan creates an image by clamping the scanner onto the exterior of the object to be evaluated and measuring the backscattered (reflected) radiation. The scanner moves a focused beam of gamma radiation across the targeted inspection area, which is about as wide as the scanner and a few centimeters tall. Basically, Constantinis explains, as the beam of radiation passes through the insulation covering the object, the radiation collides with the material's molecules. These collisions throw off tiny photons that bounce back toward a bank of gamma radiation detectors built into the scanner. As the radiation travels further and penetrates the steel, which is denser than the insulation, a greater number of photons are reflected back. The distance of the reflected photons is measured by the scanner, and the resulting measurements are processed by the accompanying computer program, which calculates the density of the materials and constructs a computer-generated, cross-sectional image that depicts the insulation and the outside diameter (OD) and the inside diameter (ID) of the steel wall, and provides a quantitative wall thickness measurement. Any diminishing thickness of the OD or ID surfaces can be identified. This enables any insulated pipe or pressure vessel, regardless of its size, to be inspected for CUI through the insulation material.
